Corrosion Analysis of API 5L Gr. Three Phase Crude

Abstract

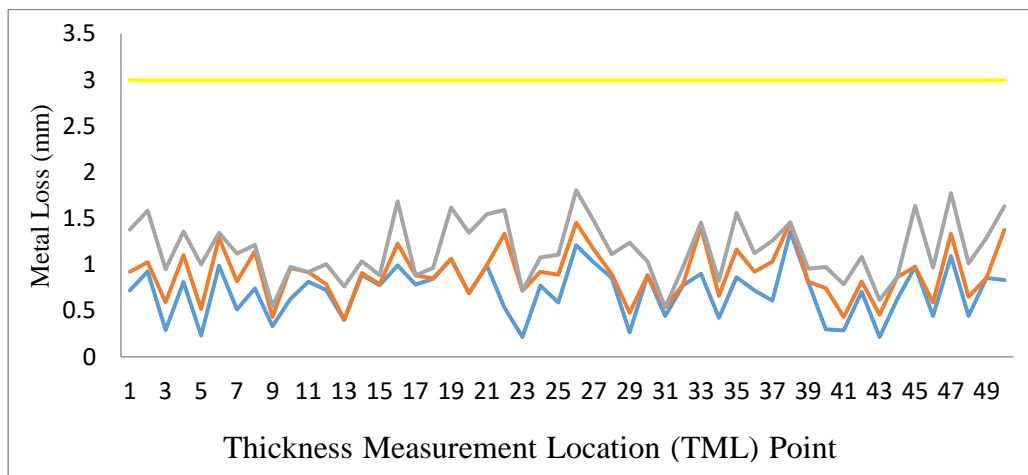
Figure 1: Plot of metal loss and the minimum corrosion allowance for the three successive in-line-inspections carried out on the three-phase crude pipeline

From Figure 1, the metal loss recorded for the three pigging periods along the pipeline showed an irregular curve pattern indicating a stochastic corrosion pattern along the pipeline. The minimum corrosion allowance is shown in the plot and is seen above the metal loss curves, indicating that the corrosion allowance is not broken and hence the pipeline is safe for continued service operation [3]. Figure 1 shows the average amount of metal loss that occurred at the 50 selected points in the pipeline between the first and second intelligent pigging i.e. 2005 and 2010, was 0.235mm, while the average amount of corrosion that occurred between the second and third intelligent pigging i.e. 2010 and 2015 was 0.304mm. The maximum metal loss from the thickness measurement location (TML) intelligent pigging data obtained was between the period of 2010 and 2015 with a value of 0.761mm at “TML Point 29” and the minimum metal loss from the thickness measurement location (TML) data obtained was between the period of 2010 and 2015 with a value of 0.040mm at “TML Point 38”. There is an average of 17.11% reduction in the amount of metal loss recorded along the pipeline between 2005 and 2015 pigging period. The result of the reduction of the metal loss may be as a result of the “Cleaning Pig” which is run through the pipeline before it is intelligently pigged using the required and desired PIG. Cleaning PIG is therefore an important criterion that is useful in the reduction of metal loss. The thickness measurement location (TML) intelligent pigging is useful for the monitoring the amount of corrosion via metal loss in a pipeline [5]. Figure 2 shows the amount of metal loss as against the minimum corrosion allowance threshold for the intelligent pigging carried out in the year 2005. It is clearly seen that the metal loss from all 50 thickness measurement locations (TML), the highest value of metal loss is 1.356mm at “Point 38”, corresponding to a minimum pipe wall thickness of 9.324mm; however, it did not intersect with the

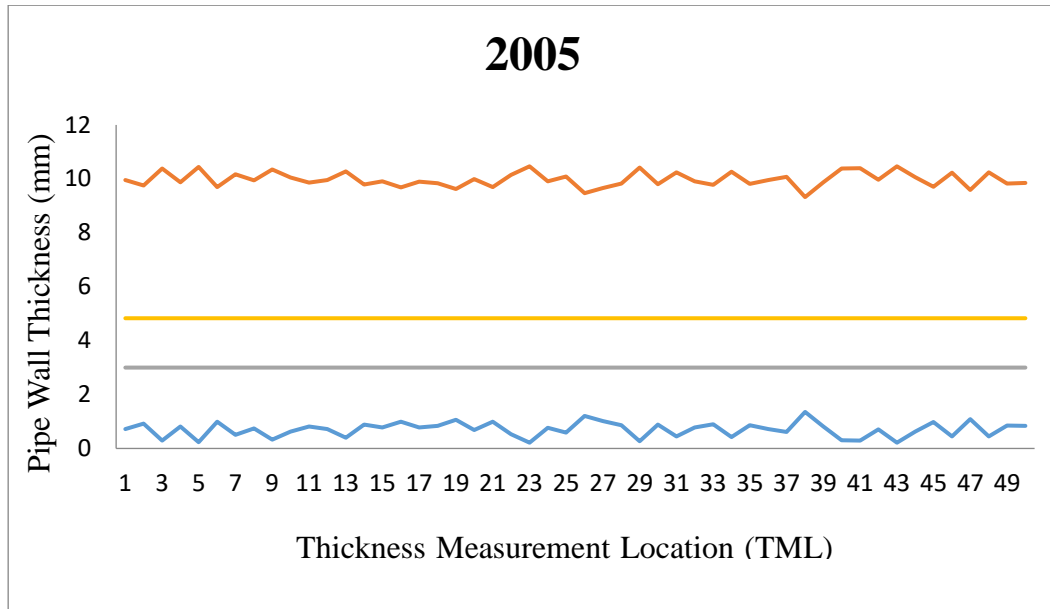
Figure 2: Plot of metal loss and remaining wall thickness against minimum specified standards after the first intelligent pigging in 2005

minimum corrosion allowance threshold of 3mm as specified by the ASME standards. This indicates that the pipeline is safe for operation. It is also seen from Figure 2 that the pipe wall thickness after the metal loss was above the minimum required pipe wall thickness of 4.83mm. From the data collected, the design data and the calculated result, the pipeline is safe for operation with respect to the pipe wall thickness requirement. Figure 2 shows the amount of metal loss, the remaining pipe wall thickness, the corrosion allowance and the minimum required pipe wall thickness after the second intelligent pigging carried out on the pipeline.

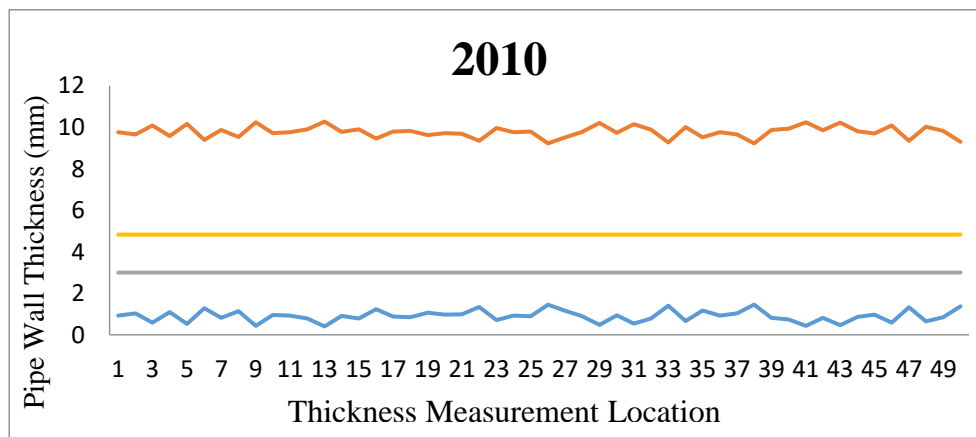
Figure 3: Plot of metal loss and remaining wall thickness against minimum specified standards after the first intelligent pigging in 2010

As seen Figure 3, the metal loss along the pipeline at all 50 thickness measurement locations (TML) did not intersect the threshold for the minimum corrosion allowance of 3mm. The highest metal loss was 1.457mm at "TML Point 38" leaving the minimum wall thickness along the pipeline to be 9.223mm. The pipe wall thickness after metal loss from second intelligent pigging carried out in 2010 did not intersect with the minimum required pipe wall thickness of 4.83mm. The intelligent pigging data collected when compared with the design data and calculated result indicates the pipeline is deemed safe for continued operation with respect to the pipe wall thickness requirement.

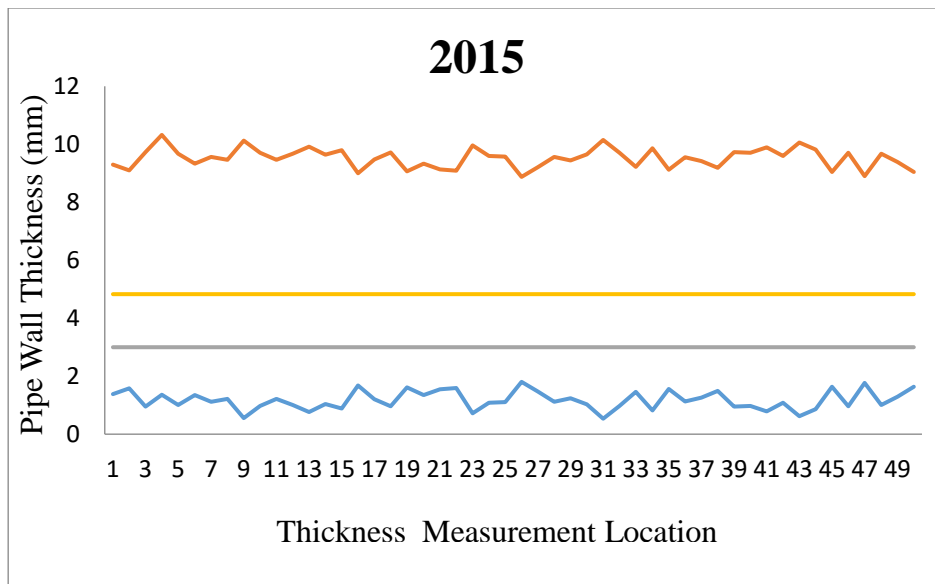
Figure 4: Plot of metal loss and remaining wall thickness against minimum specified standards after the first intelligent pigging in 2015.

Figure 4 shows the metal loss, the pipe wall thickness after metal loss, the minimum corrosion allowance and the minimum required pipe wall thickness after the third successive intelligent pigging carried out on the pipeline in 2015. The maximum metal loss was 1.805mm at "TML Point 26", leaving the minimum wall thickness along all 50 thickness measurement locations (TML) along the pipeline to be 8.875mm. The metal loss at all 50 thickness measurement locations (TML) did not intersect the minimum corrosion allowance of 3mm. The pipe wall thickness after the metal loss also did not intersect the minimum required pipe wall thickness of 4.83mm. The result indicates that the pipeline is deemed safe for operation with respect to the pipe wall thickness requirement [6].

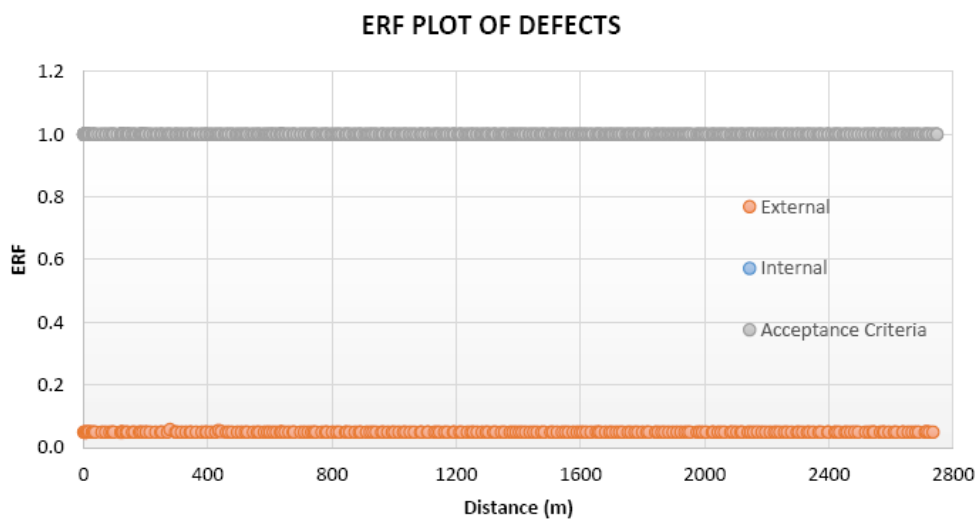
Figure 5: Plot of estimated repair factor (ERF) of defects along pipeline

The estimated repair factor (ERF) of the defects along the pipeline is plotted along the acceptable ERF criteria in Figure 5. The acceptable ERF for the pipeline at any location is ≤ 1 as required by the ASME B31.4 standard. Any ERF value at any location along the pipeline greater than this value, such location should further be analyzed using a less conservative assessment procedure (e.g. RSTRENG, Finite Element Analysis etc.) or, otherwise, the defect should be repaired using an approved procedure (e.g. replacement of the affected section or encirclement by a pressure retaining clamp); however, from Figure 5, no ERF value along the pipeline exceeded the acceptable value. The highest ERF value recorded was 0.06.

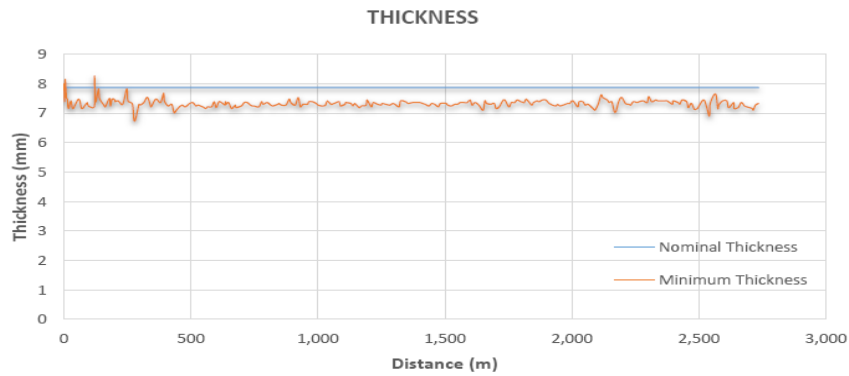
Figure 6: Plot of average thickness compared with the nominal thickness of the pipe

It is seen in Figure 3.6 that the recorded minimum wall thickness is lower than the nominal thickness as specified by the manufacturer; however, it is below the minimum wall thickness of 4.6mm, implying that the pipeline is safe for service operation with respect to the pipe wall thickness. The plot of the minimum thickness in Figure 6 is relatively uniform, implying a uniform corrosion on the external walls of the pipeline

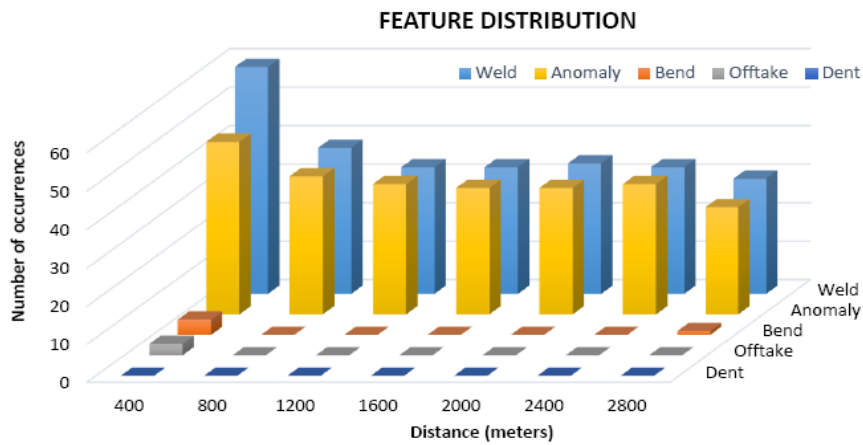
Figure 7: Plot of feature distribution along pipeline

Figure 7 show the plot of the feature distribution along the pipeline as recorded by the smart pig. From the pigging data downloaded, this pipeline has 260 welds, 5 bends, 3 off takes, 243 anomalies. There was no dent recorded along the pipeline. The severity of the anomaly with respect to the percentage metal loss along the pipeline is shown Figure 8. From Figure 8, the highest number of anomaly occurrence occurs at a distance of 0-800m. Between 800-2400m, the number of anomalies occurring was steady and then a further reduction in the number of anomalies occurring was recorded at last 400m of the pipeline. Figure 8 indicates that the immediate environment of the first 400m of the pipeline encourages more corrosion while the last 400m resist corrosion. The plot above indicates that the pipeline passes through three (3) separate environments. Figure 9 show the peak depth distribution along the pipeline. The plot shows that all peak depth (metal loss) recorded are all external, indicating no internal metal loss in the pipeline.

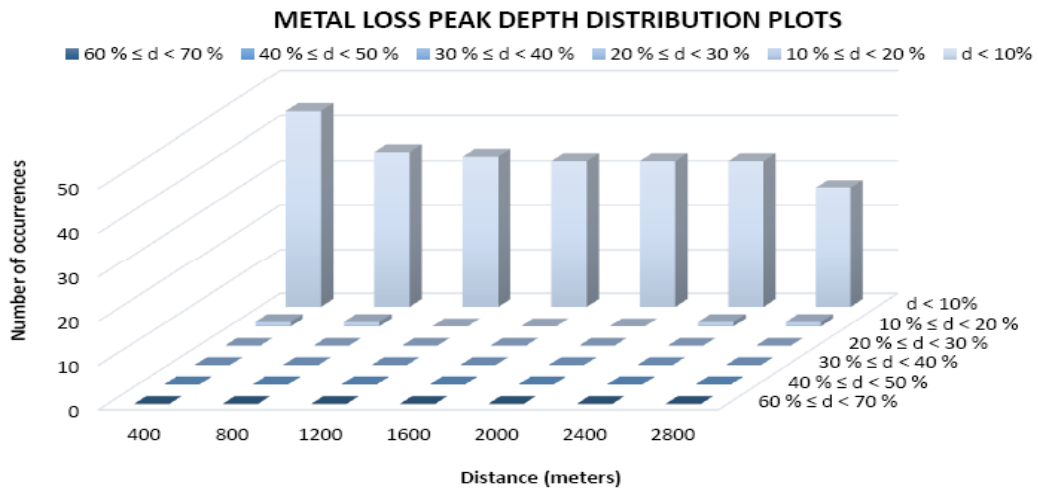
Figure 8: Metal loss peak depth distribution plot

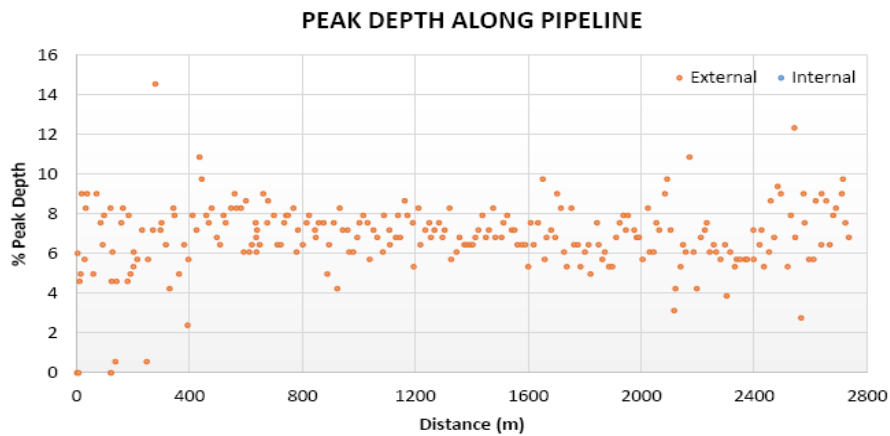
Figure 9: Peak depth along pipeline

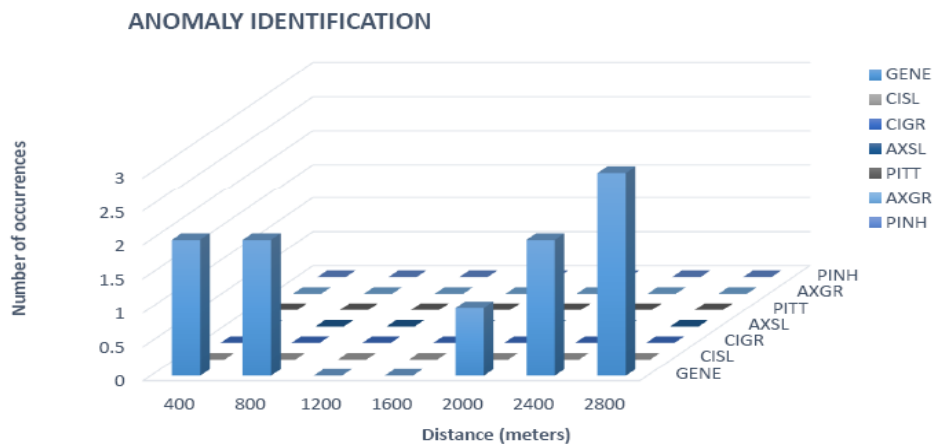
Figure 10: Plot of anomalies identified along the pipeline

Figure 10 show the plot of the identified anomalies and their number of occurrences. It is seen that the only identified anomaly is "General Corrosion" which from Figure 9 occurred at the external surface of the pipeline. It shows 10 number of occurrences with the highest occurrence of 3at distance of 2800m.
