Analysis of shell failure of a semi-trailer tanker used for hauling petroleum products

T.N. Guma^{a*}, K.V. Odita^{b*}, N.C.A. Ozoekwe^{c*}, and T. Akor^{d*}

Department of Mechanical Engineering, Faculty of Engineering and Technology, Nigerian Defence Academy, PMB 2109, Kaduna, Nigeria

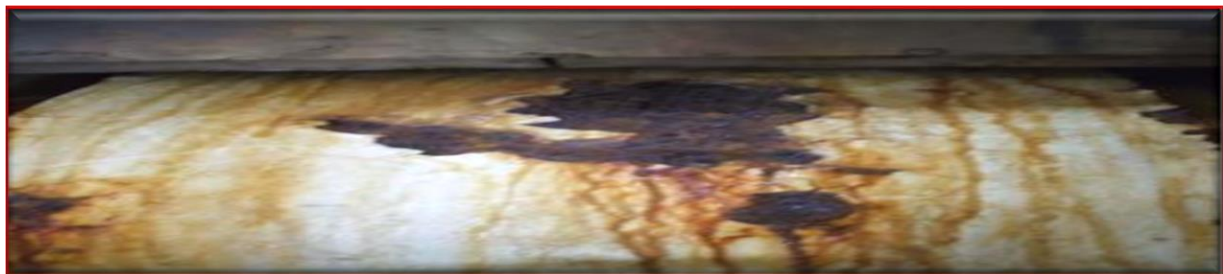
Visual examination of the failed semi-trailer shell was conducted at ARMECO where the trailer was parked awaiting repair of the shell. The examination showed that the trailer shell was made of steel material and had a faintly visible quasi-transverse brittle crack perforation of about 25 cm lengths where it was previously arc-welded to seal a previous perforation at the spot and repainted. The paint however got worn out at the spot and before the shell failure in question occurred around the same spot where it was sealed. Pictures were then taken with a Nikon 990 digital camera through a Nikon Stereoscopic microscope at a magnification of 20. Plate I is the picture of the point on the shell where the trailer was repaired, repainted but rather deteriorated and perforated and outpoured fuel from the perforation marred the trailer body. Plate II on the other hand is the surface appearance of the weld-repair failure location on the trailer.

Plate I: Point on the semi-trailer shell before it was last arc-weld-repaired but later deteriorated and failed.

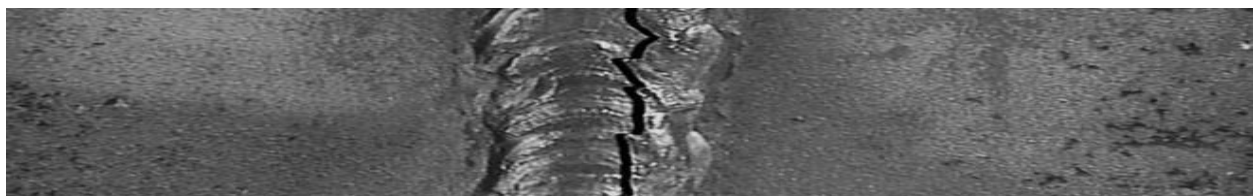
Plate II: A magnified view of the actual weld-repair failure location

In all and all, collated field and test information vividly indicated that the shell failed following an improper weld-repair work on it which created a debased material location with wide differences in metallography and chemical composition, and increased corrosion rates and weight losses by comparison to the as-made shell mild steel. These presumably raised the location stresses amid dynamic effects from frequent bad road conditions, and caused the shell to crack along the weld seam of the previous repair work.

To forestall future occurrence of this and other related failures, it is suggested that companies that use semi-trailers for hauling petroleum products in Nigeria beef up timely and proper corrosion monitoring, inspection, servicing, and repairs of their semi trailers and other related vehicles by employing the services of competent, committed and dedicated personnel with correct working tools or facilities in line with stipulated or standard maintenance practices for the vehicles.

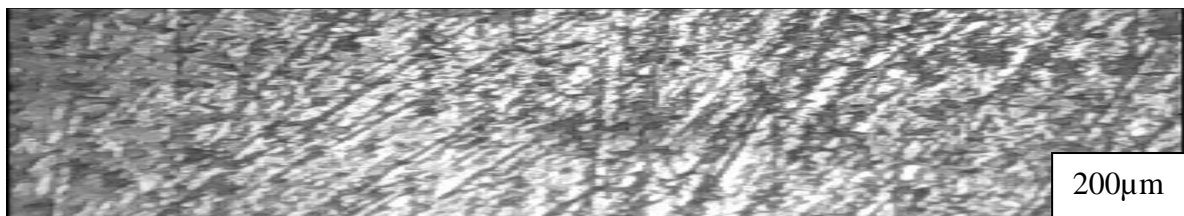
Plate VIII: SEM microstructure a sample got at away location from where the shell failure occurred

In Plates VIII to XV, it can also be observed that the metallographies and surface morphologies of samples prepared with the steel make materials gotten at and away from the shell failure location were very different. Plate VIII shows a more consistent microstructure than plate IX which is heterogeneous. It is notable that for a material to perform optimally in corrosion behavior and strength, it needs among other requirements to be homogeneous. Lack of homogeneity in the shell make low carbon steel around the failure location as indicated by Plates IX was seen to have aggravated corrosion rates at the location. Inimical forms of corrosion such as galvanic corrosion, selective removal of some metallic ions, corrosion fatigue, and stress corrosion cracking might have been responsible for failure of the shell [16, 17]. Plates X to XV also show different surface morphological characteristics of the exposed coupons in the prepared media. This agrees with the earlier discussion that corrosion behavior of the shell make material at and away from the failure locations are different.

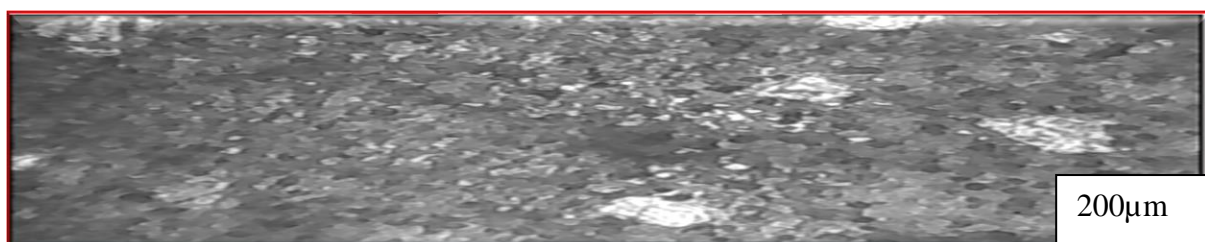
Plate IX: SEM micro-structure of a sample from the failure location of the semi-trailer shell

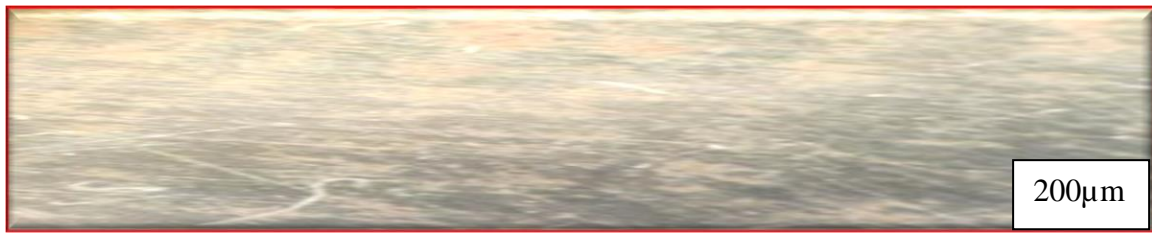
Plate X: SEM surface morphology of a sample from the failure location after it was immersed continuously for 1200 hours in as-received gasoline media

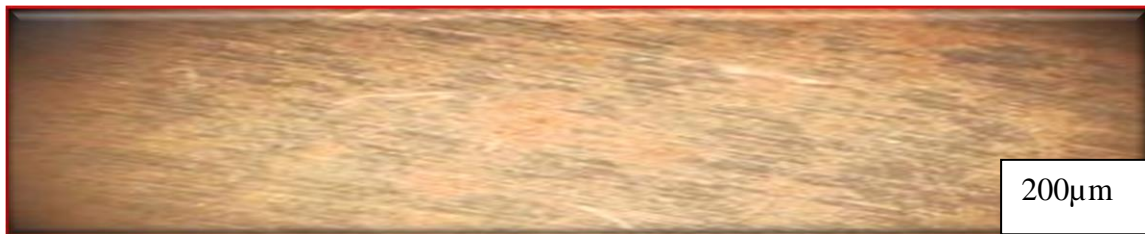
Plate XI: SEM surface morphology of a sample from the failure location after it was immersed continuously for 1200 hours in the as-received diesel media

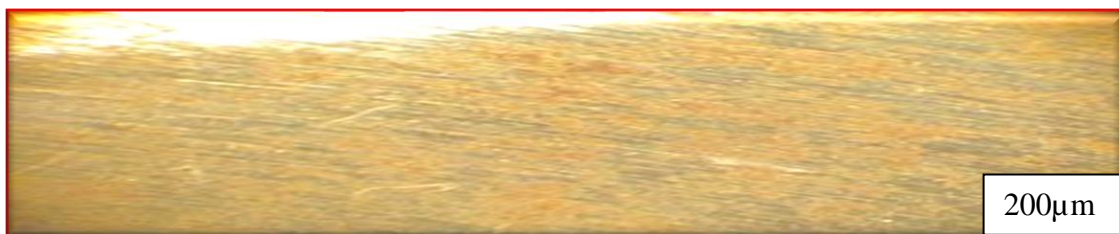
Plate XIII: SEM surface morphology of sample from steel got on the semi-trailer shell adjacent the shell failure location after it was immersed continuously for 1200 hours in the as-received diesel media

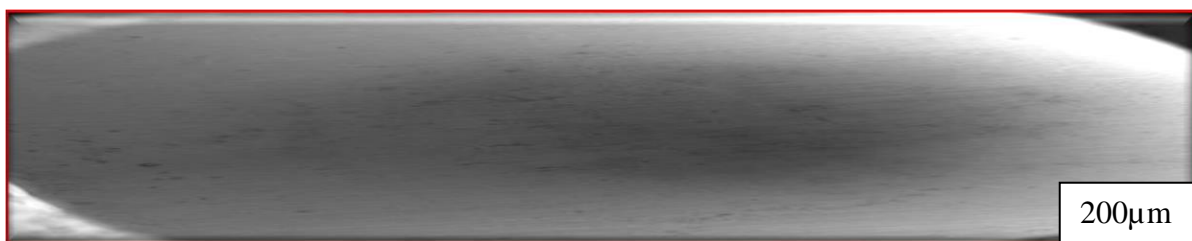
Plate XIV: SEM surface morphology of a sample from the failure location after it was immersed continuously for 1200 hours in as-received gasoline media that contained 25% Wt of concentrated H_2SO_4

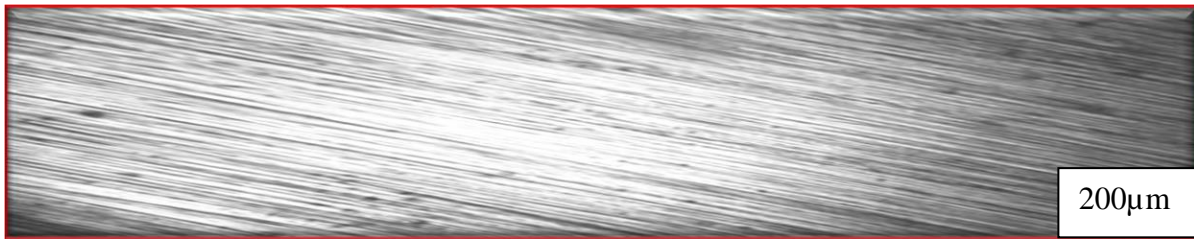
Plate XV: SEM surface morphology of a sample from the failure location after it was immersed continuously for 1200 hours in a diesel media containing 25% Wt of concentrated H_2SO_4
