## Environmental Impact of Scrap Metal Industries: Examination of Vertical Seepage of Scrap Metal Effluents (Heavy Metals) into the Aquifer

Research was carried out to determine the extent of damage caused by the release of heavy metals from scrap metal dump sites into the aquifer in Benin City, Nigeria. The nine scrap metal dump sites investigated were located at; i) Osasogie Street by Total Filling Station, Off Benin Sapele Road, ii) Omoragbon Agho, Off Benin Sapele Road, Etete, iii) Eybuotubu Junction by Ekehuan Road iv) Asoro Hill by Upper Ekehuan Road v) Christopher Osewengie Street, Ekae Quarters, off Sapele Road, vi) Akugbe Street, off Saint Saviour Road, vii) Upper Iwehen, off Lagos Street, Oba Market, viii) Evbienwen Street, off Wire Road and ix) Iduowina Road, Iduowina Quarters, off Benin Auchi Road. The control site was located at Uniben Reserved Area, University of Benin, Benin City. Water samples were obtained from hand dug wells, private boreholes and rivers closest to scrap metal dump sites. The distance between the sites and water sources were measured using a global positioning satellite (GPS) device. The Atomic Adsorption Spectrophotometer (AAS) was used to analy

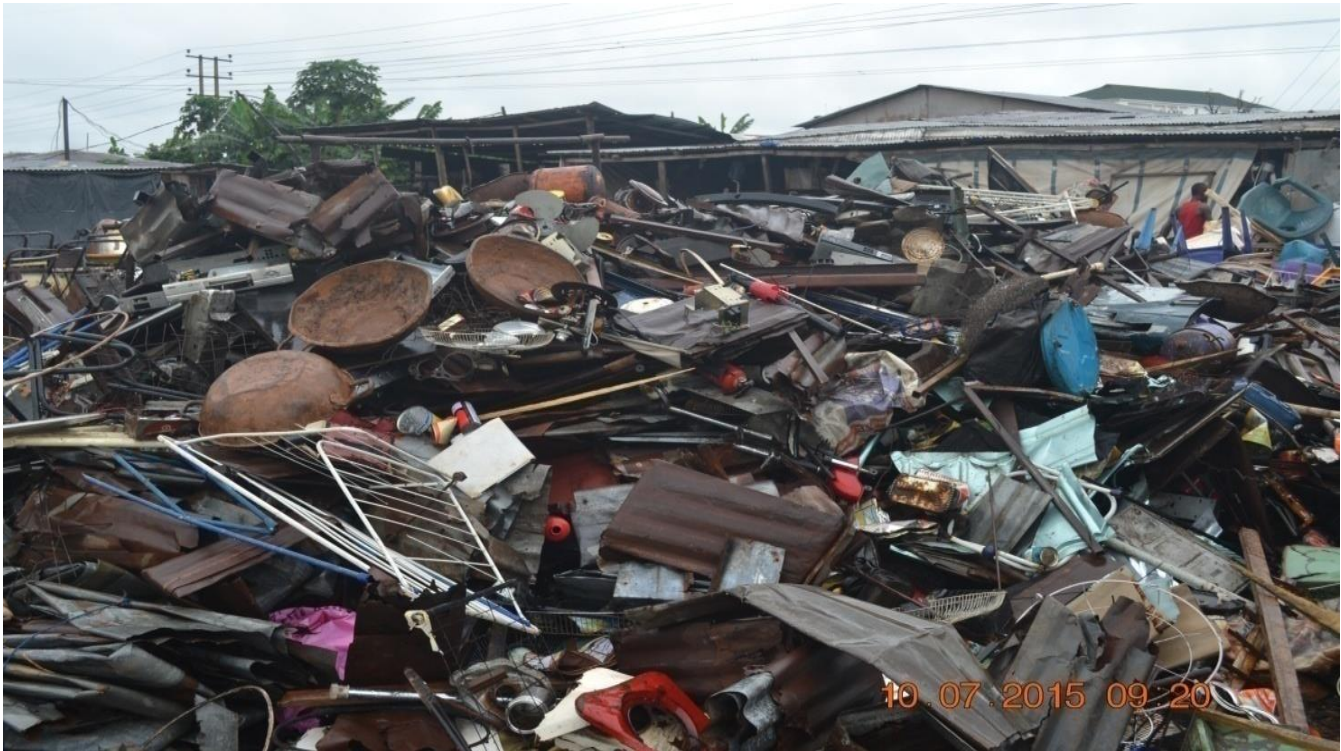
Plate 1 below shows the picture of a scrap metal dump site at Etete. The site serves as a collection point for recyclers of scrap metals. The picture also reveals that the scrap metal dump site is located in the heart of the city where people reside. A close view at Plate 2 shows that in Etete scrap metal dump site, the scrap metals were heaped directly on the plain soil, exposing the soil directly to the eroded metals. This therefore shows that the soil serves as a bed for water run-off from the scrap metal dump site. In plate 3 below, the borehole located around the scrap metal dump site at Etete, pumps water from the ground into the black tank. This polluted water serves as a source of drinking water to the people residing in that area. Similar conditions were seen in all the sampled sites.

Plate 1: Heap of scrap metals at Etete, Benin City, Nigeria

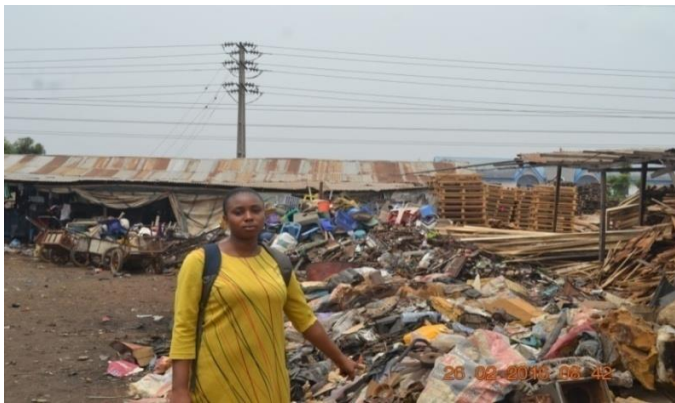
Plate 2: Heap of scrap metal at Etete

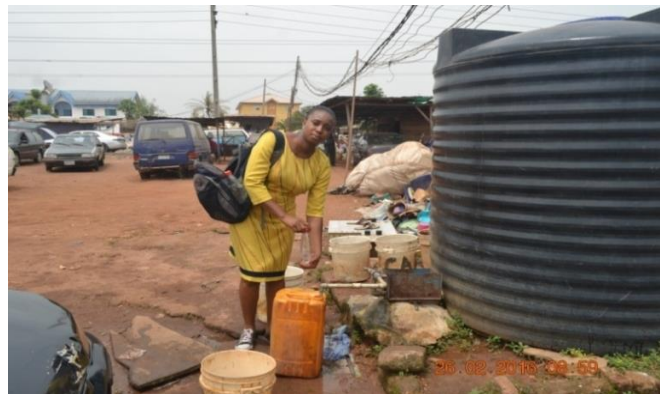
Plate 3: Bore hole close to scrap metal
