## Towards Automation of Building Integrity Tracking: Review of Critical Causes and its Impact on Building Structures in Nigeria

*Building structures, Collapsed Structure, Failure, Real-time Wireless implementation, Integrity Monitoring, Risk Factor*

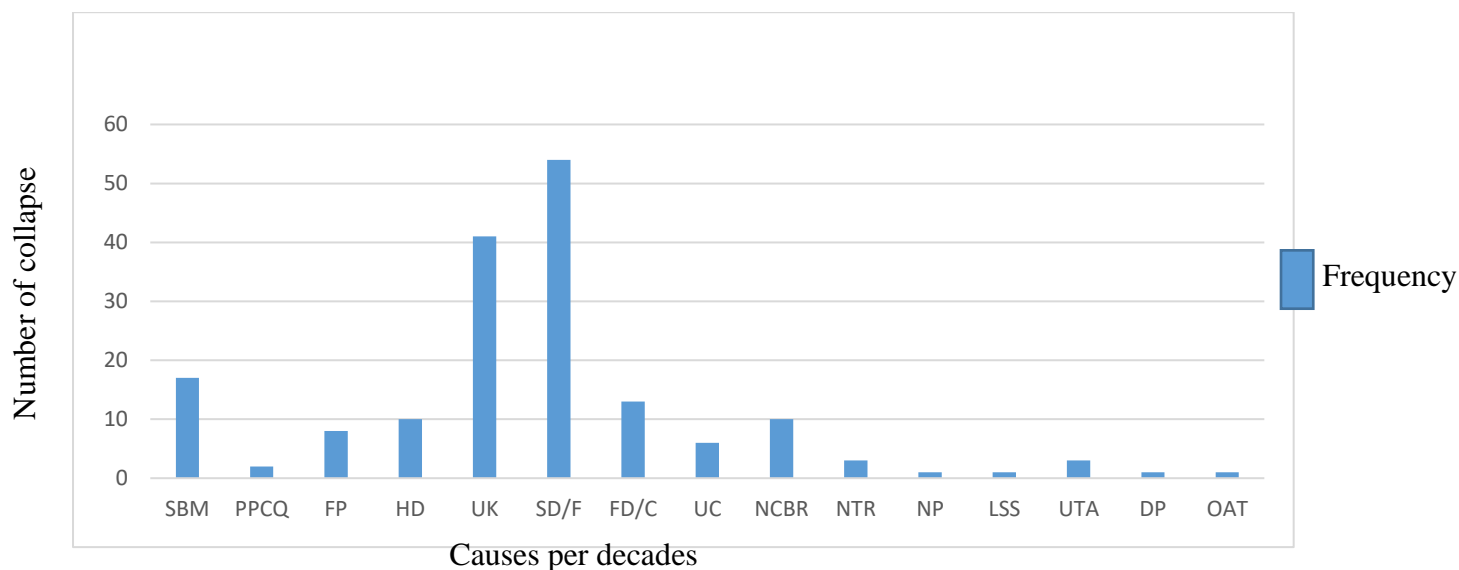
Figure 1- Collapse based on causes of Collapse

Analyzing the above data in Figure 1, we discovered that the case of structural defects/ failure occurred frequently with 54 cases out of the 172 cases that were reviewed. From here it can be seen that among other causes that occurred, the structural defects/failure has the highest rate of occurrences on the issues of building collapses and the deaths.

In this work, after the computation of the number of course, it was discovered that there were 172 (one hundred and seventy two) has affected the building structures based on the period under review (1973 – 2022). While the structural failure/defect has the highest of frequency occurrence, with 54 courses (31.40%) and can be found in the Figure 1.

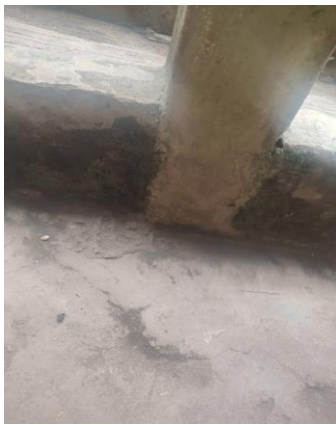
Fig. 2 Crack at the foundation

For the visual inspection, that was carried out by the authors, using the digital cameras, on the different parts of the building structures, it was discovered that several cracks both longitudinal and transverse were observed especially in the joint between structural components such as the beam and column, beam and roof, beam and foundation and also along the beam, column, wall, and so on. Some of these cracks were found to run from the floors to the roofs. Figure 1 – 8 represents the photographic image of several types of cracks on the different portions of the building structure. From the figures shown, it can be observed the cracks are visible at the plaster of the brick wall or stone wall depending on the type of the building structure, which is an indication of a serious structural issues on the building. Whether the cracks are diagonal, vertical or horizontal, if left unattended to, they could lead to foundation problem in the future, apart from this, and other causes that were also observed were:

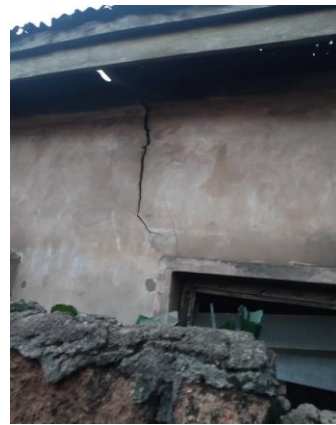
Fig.3 Crack around the beam

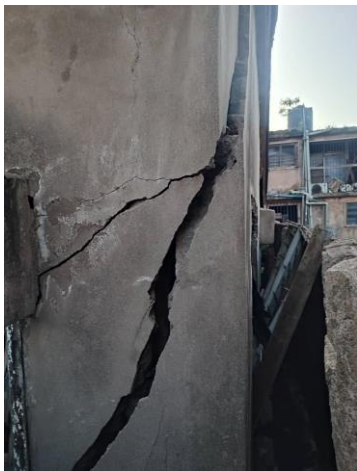
Fig. 4 Diagonal crack at the column

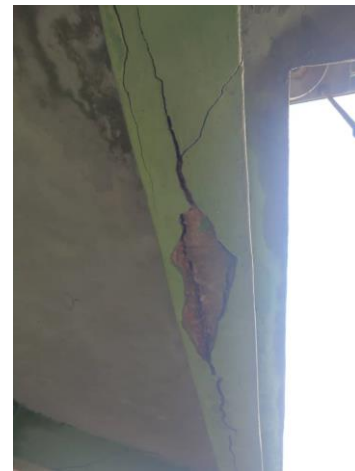
Fig. 5 Crack along the beam

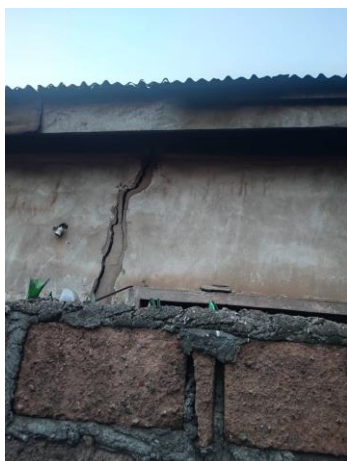
Fig.6 Crack on the wall

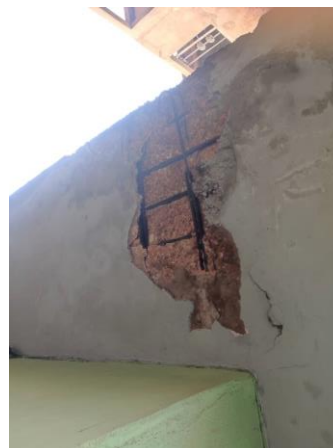
Fig.7 Crack on the decking
