Analysis of shell failure of a semi-trailer tanker used for hauling petroleum products

T.N. Guma^{a*}, K.V. Odita^{b*}, N.C.A. Ozoekwe^{c*}, and T. Akor^{d*}

Department of Mechanical Engineering, Faculty of Engineering and Technology, Nigerian Defence Academy, PMB 2109, Kaduna, Nigeria

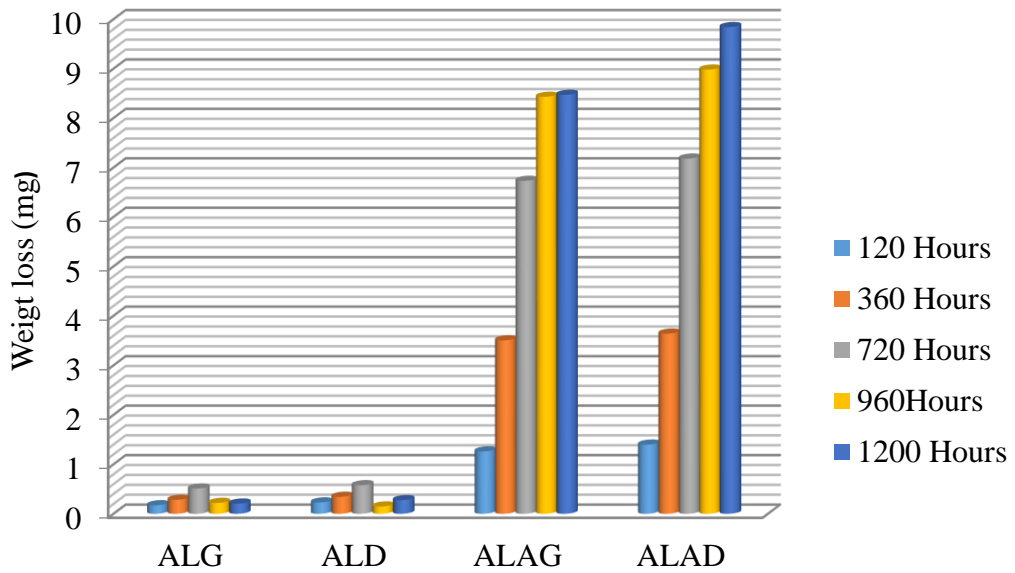
Fig. 1: Weight losses of coupons (mg) after immersing them for various durations of 120-1200 hours in as-received gasoline and diesel media

In Fig. 1 to 5, it can be seen that corrosion weight losses and rates of samples prepared from the shell make component gotten at and away from the failure location of the shell exhibited different values for the same exposure durations of 120 to 1200 hours in each of the prepared media. In all cases the corrosion weight losses increase with the exposure duration and ranged from 0.172 to 9.87mg as can be observed from Fig.1 to 5 while the corrosion rates ranged from 0.0075 to 0.061mm/yr as can be observed in Fig. 6 to 10. In all cases, Fig. 1-5 and 6-10 indicate that the corrosion weight losses and rates of prepared samples with the shell make component got at the failure location are higher than those of samples from the shell make component got at away location from the failure location under the same respective gasoline or diesel media and exposure durations. The corrosion weight losses and rates therefore clearly support the chemical analysis that the shell make material at its failure location was very different from the original mild steel used in constructing the shell.

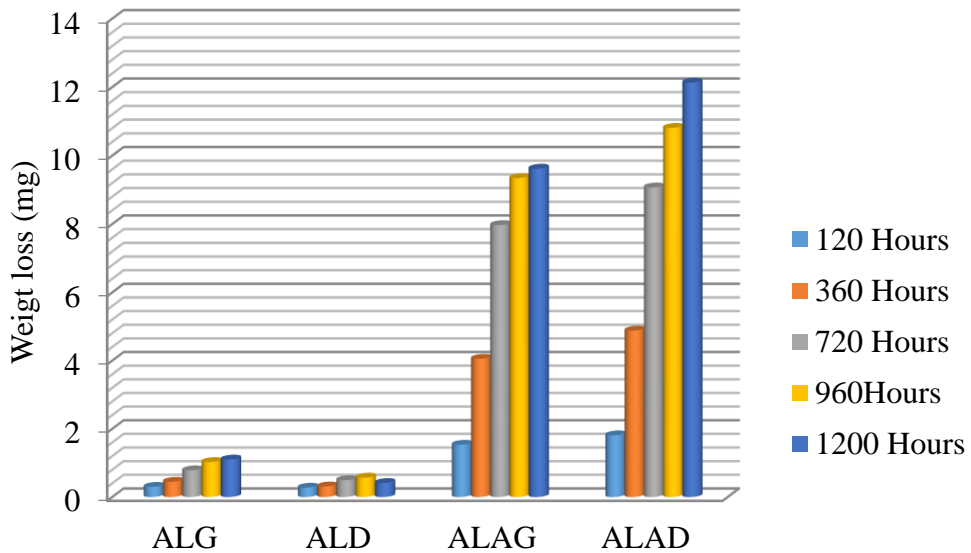
Fig. 2: Weight losses of coupons (mg) after immersing them for various durations of 120- 1200 hours in gasoline and diesel media containin 5% by Wt of concentrated H₂SO₄

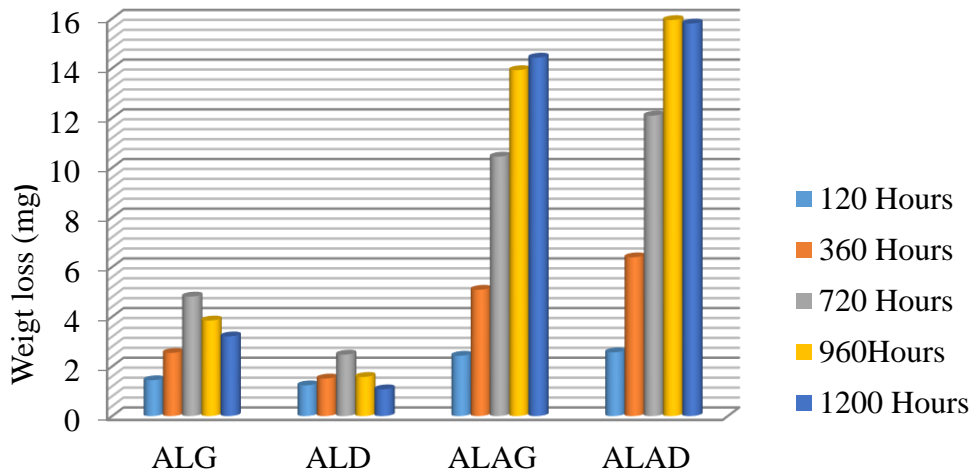
Fig. 3: Weight losses of coupons (mg) after immersing them for various durations of 120-1200 hours in gasoline and diesel media containing 10% by Wt of concentrated H_2SO_4

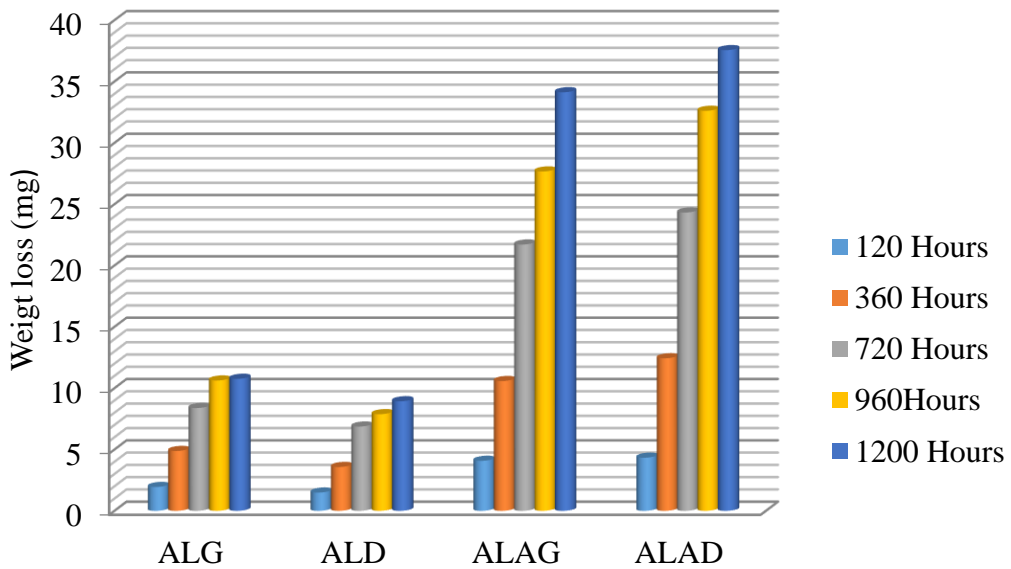
Fig. 4: Weight losses of coupons (mg) after immersing them for various durations of 120- 1200 hours in gasoline and diesel media containing 15% by Wt of concentrated H_2SO_4 .

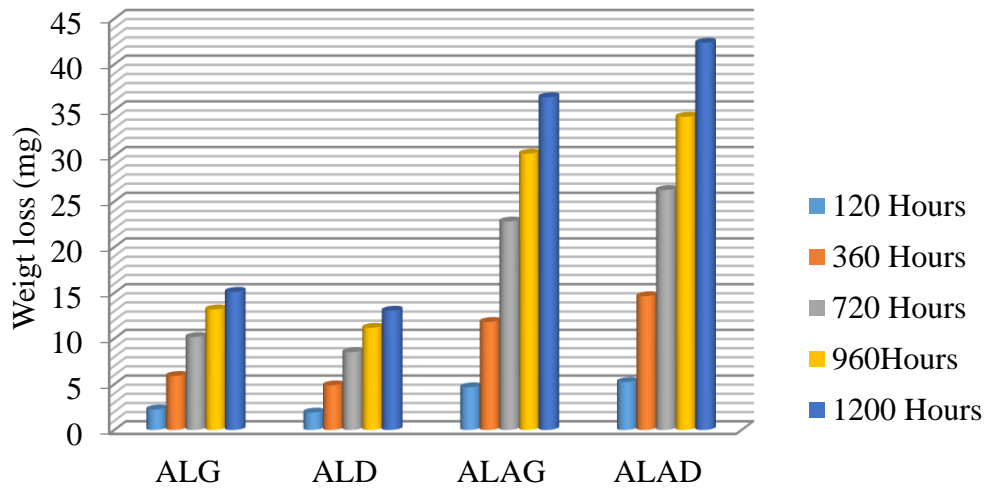
Fig. 5: Weight losses of coupons (mg) after immersing them for various durations of 120-1200 hours in gasoline and diesel media containin 25% by Wt concentrated H₂SO₄

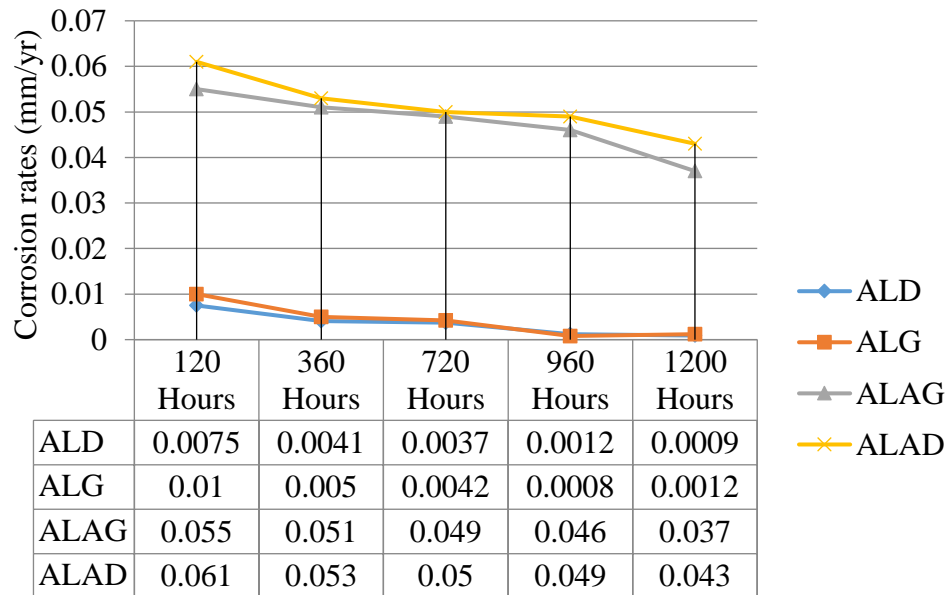
Fig. 6: Corrosion rates of samples after immersing them for the specified durations (Hours) in as-received gasoline and diesel media

According to atmospheric corrosivity categorization by ISO 9223 1992 from the point of view of corrosiveness to carbon steel as the base material; corrosion rates of 0 up to 1.3mm/yr are very low, corrosion rates of more than 1.3mm/yr up to 25mm/yr are low, corrosion rates of more than 25mm/yr up to 50mm/yr are medium, corrosion rates of more than 50mm/yr up to 80mm/yr are high, and corrosion rates of more than 80mm/yr up to 200mm/yr are very high [15]. From these categorizations and the results presented in Figs. 6, it is evident that the as-received gasoline and diesel media per se had negligible effects on corrosion rates on all the shell make steel samples. The diesel media however exhibited greater corresponding losses and rates than the gasoline media under the same concentrations of H_2SO_4 and exposure durations of the samples as can be seen from Figs. 1-10. These clearly indicate that petroleum products per se which are hauled by the semi-trailer have negligible effects on corrosion of the shell make steel. Therefore environmental exposure corrosive factors from the atmosphere, soil, and humans coupled with dynamic effects from bad road conditions are seen to have been responsible for some forms of corrosion that caused the shell to fail by cracking.

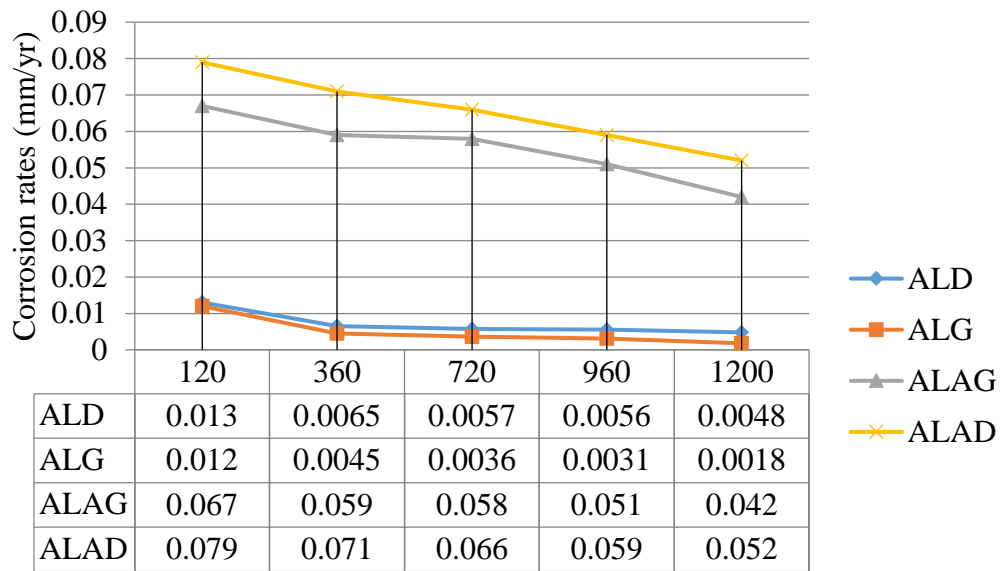
Fig. 7: Corrosion rates of samples after immersing them for the specified durations (Hours) in gasoline and diesel media containing 5% by Wt of concentrated H₂SO₄

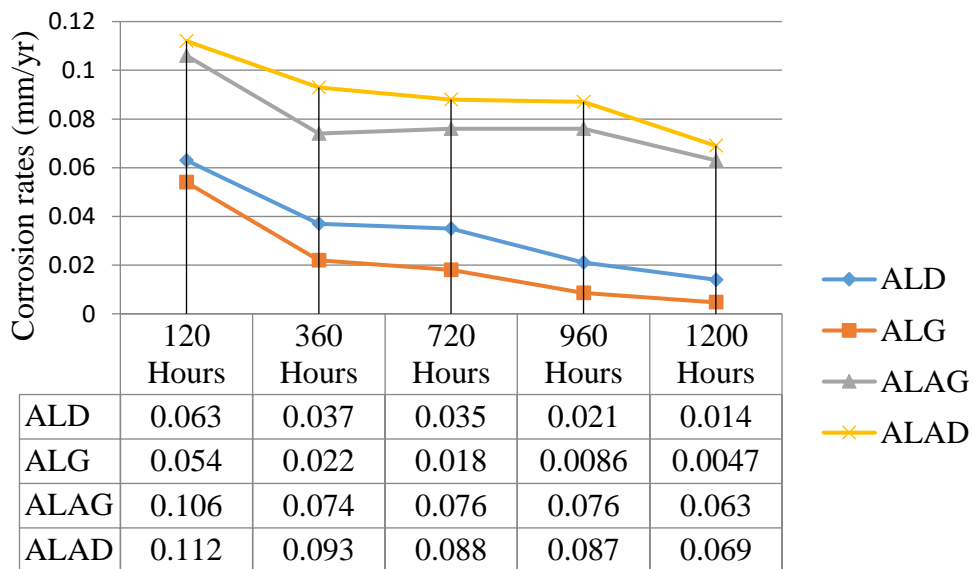
Fig. 8: Corrosion rates of the samples after immersing them for the specified durations (Hours) in gasoline and diesel media containing 10% by Wt of concentrated H₂SO₄

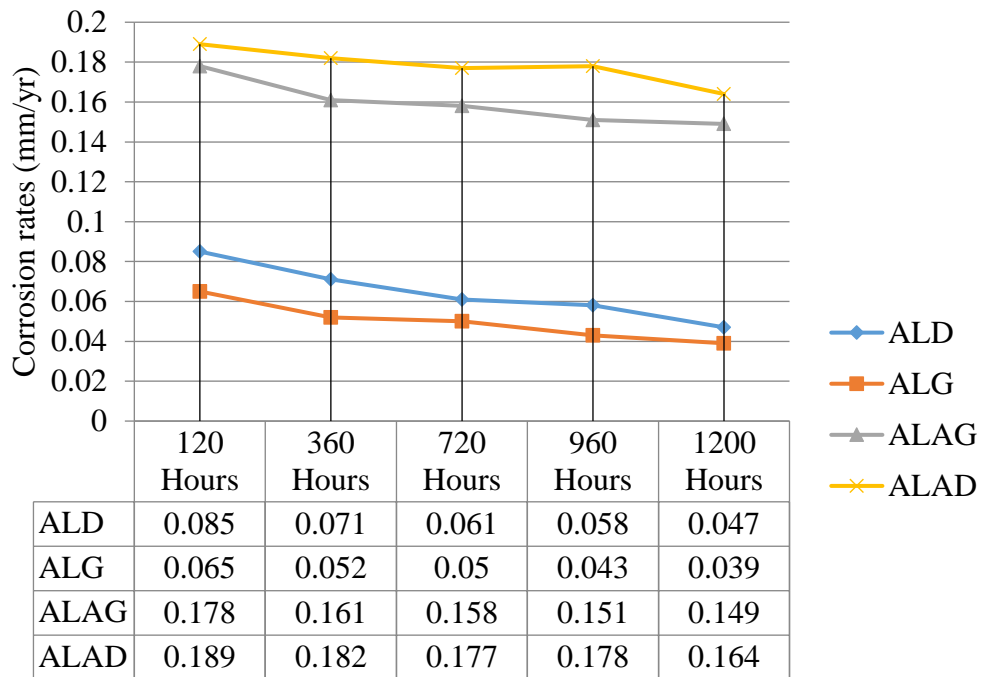
Fig. 9: Corrosion rates of samples after immersing them for the specified durations (Hours) in gasoline and diesel media containing 20% by Wt of concentrated H_2SO_4

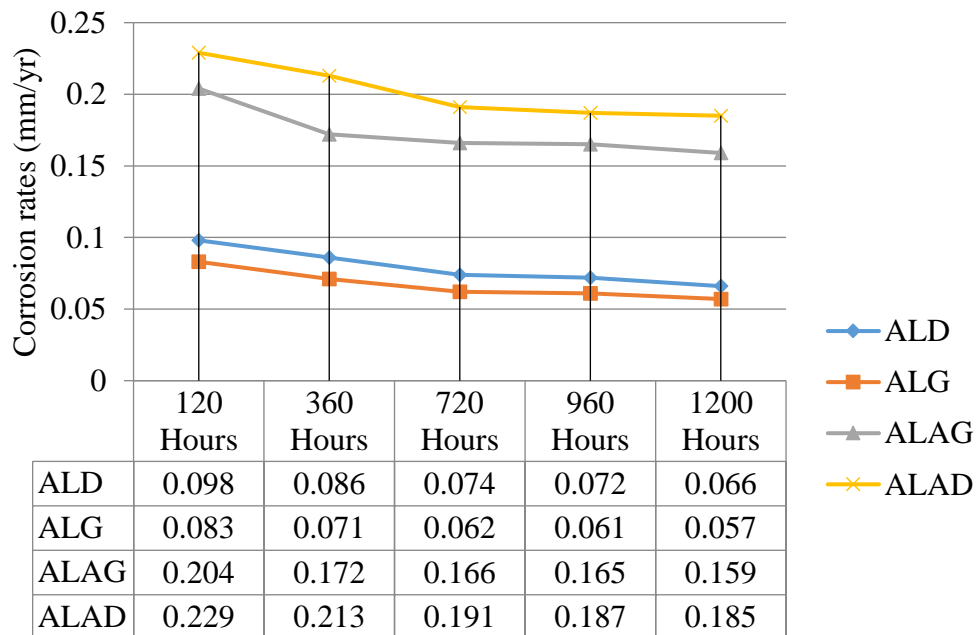
Fig. 10: Corrosion rates of samples after immersing them for specified durations (Hours) in gasoline and diesel media containing 25% by Wt of concentrated H_2SO_4
